DRAINAGE REPORT

MIDCOAST STORM DRAIN INVENTORY AND ASSESSMENT PROJECT

THE COUNTY OF SAN MATEO

February 8, 2013

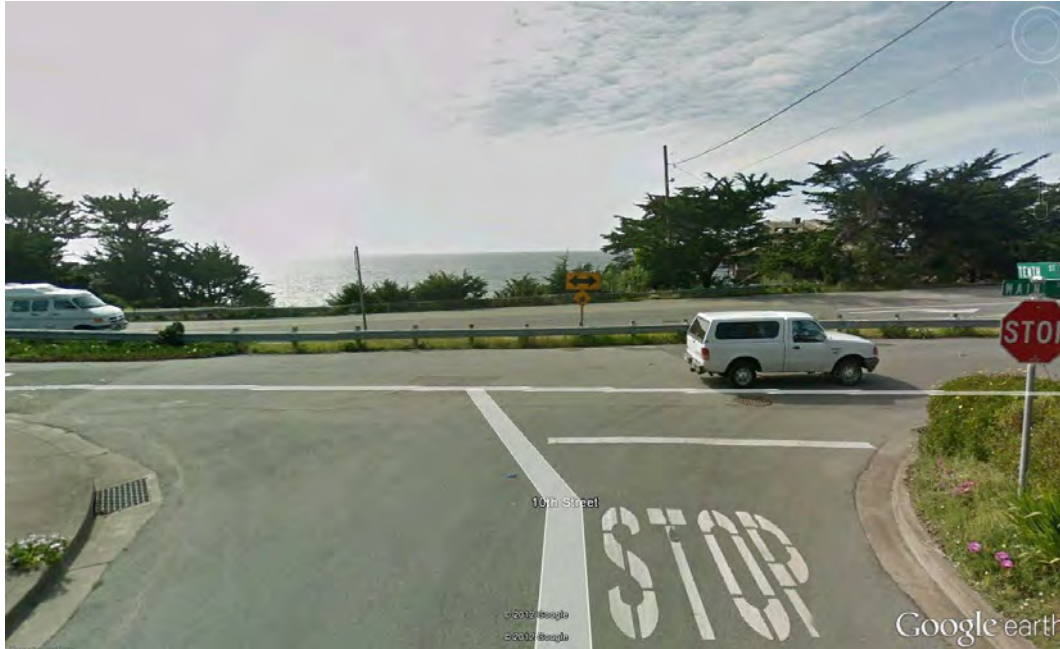
Photo 1: BMP-1 ~ CDS unit at 10th St & Cabrillo Highway

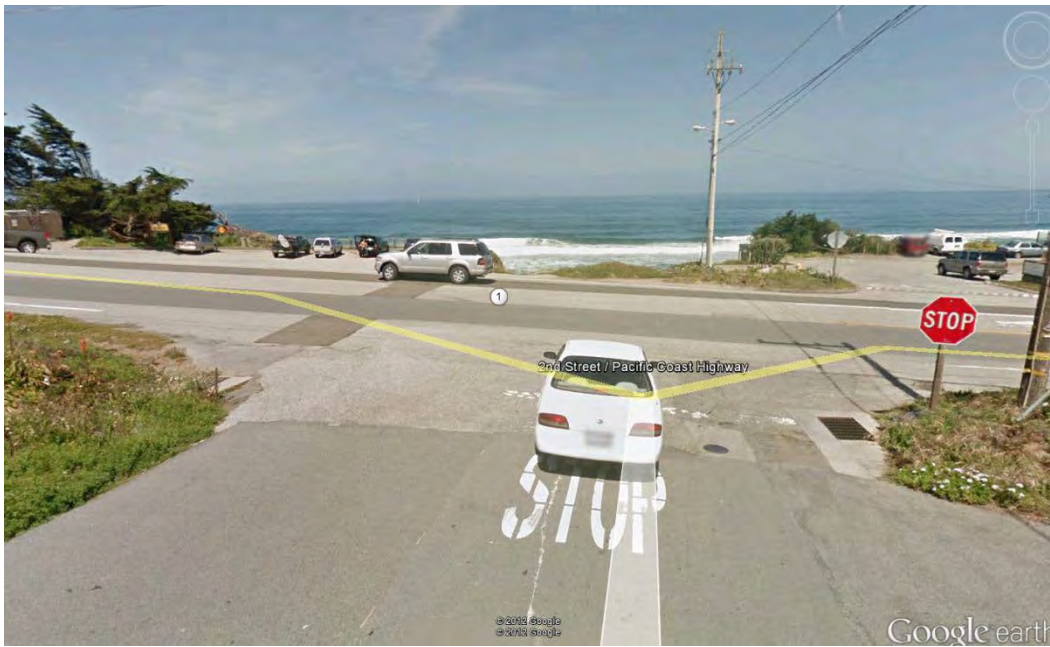
2: BMP-2 ~ CDS unit at 2nd St & Cabrillo Highway

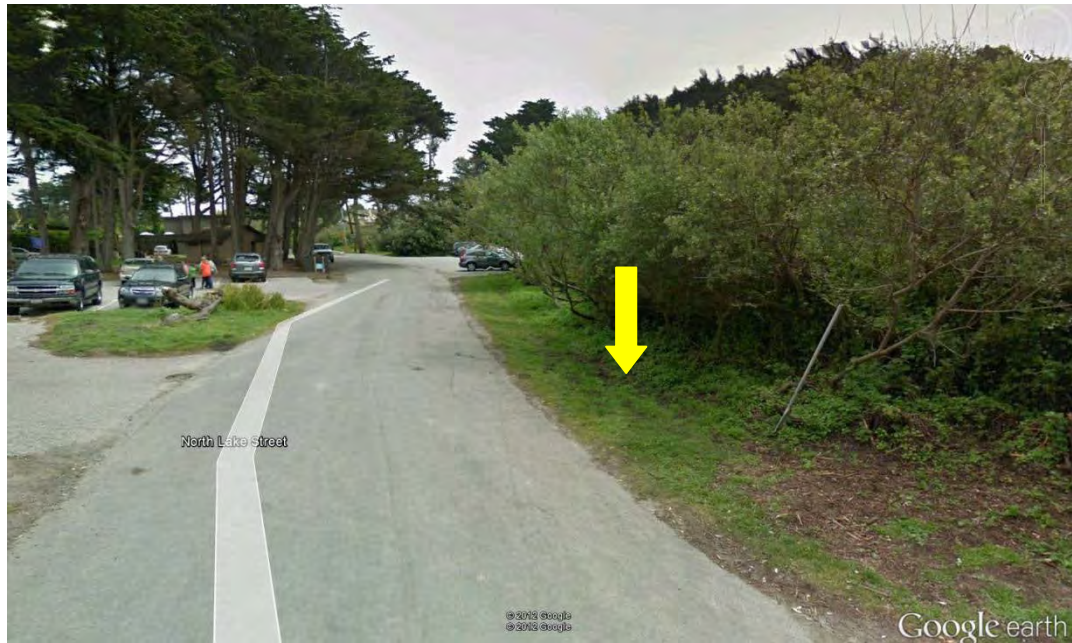
Photo 3: BMP-3 ~ Vegetated swale on North Lake St at Nevada

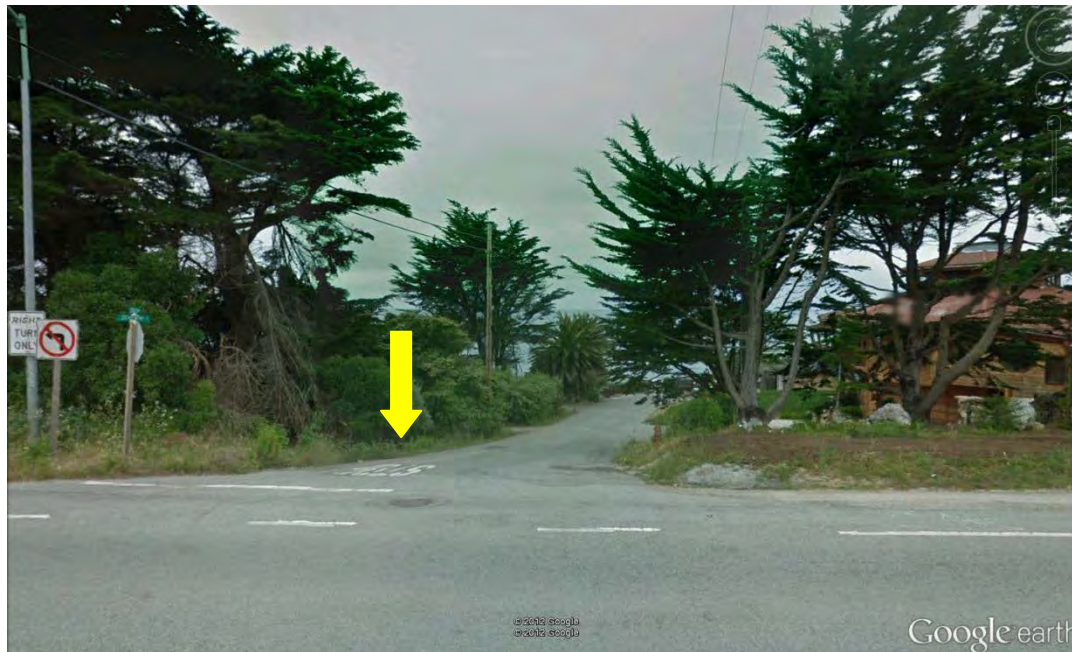
Photo 4: BMP-4 ~ Vegetated swale on Seventh St (west of Cabrillo Highway)

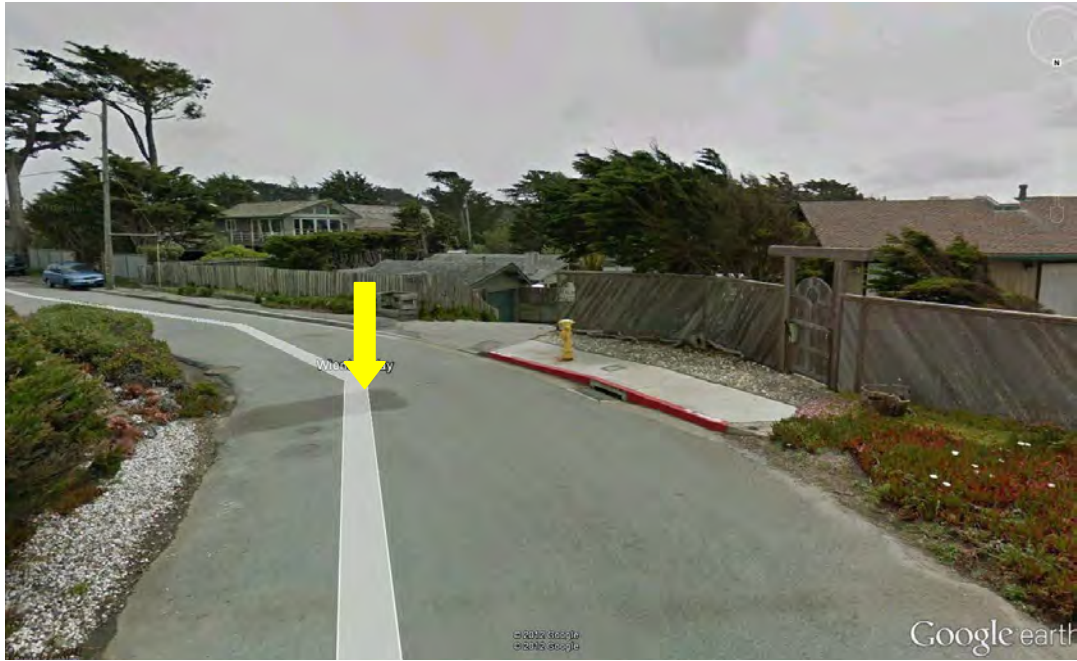
Photo 5: BMP-5 ~ Catch basin filter cartridges to be installed in Manhole on Wienke Way/Juliana Avenue

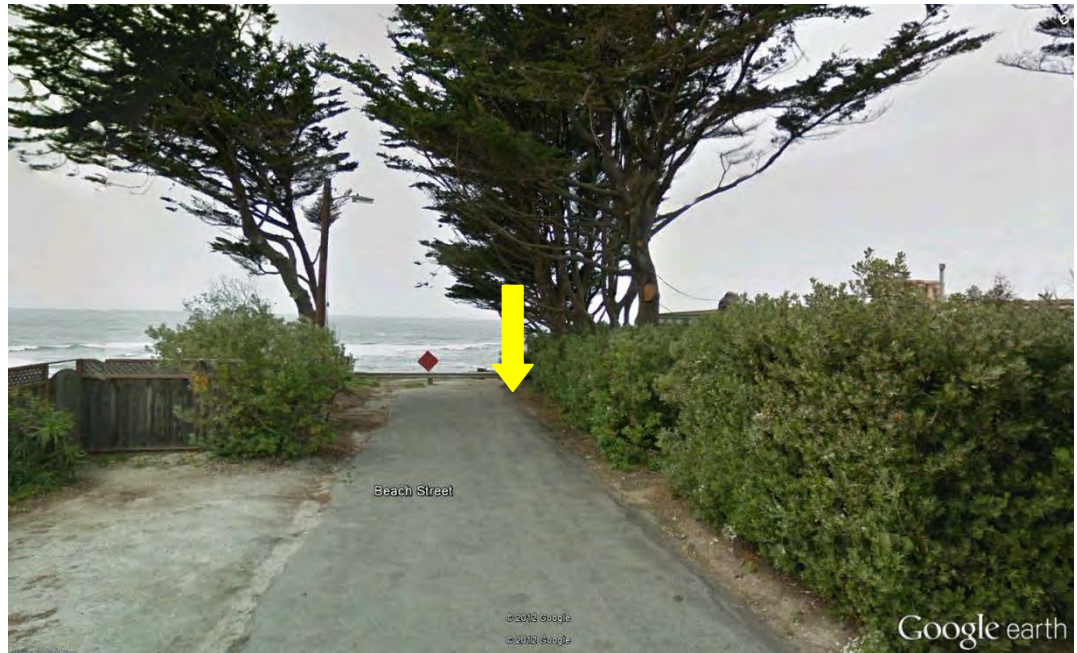
Photo 6: BMP-6 ~ Flume filter at end of Beach Street

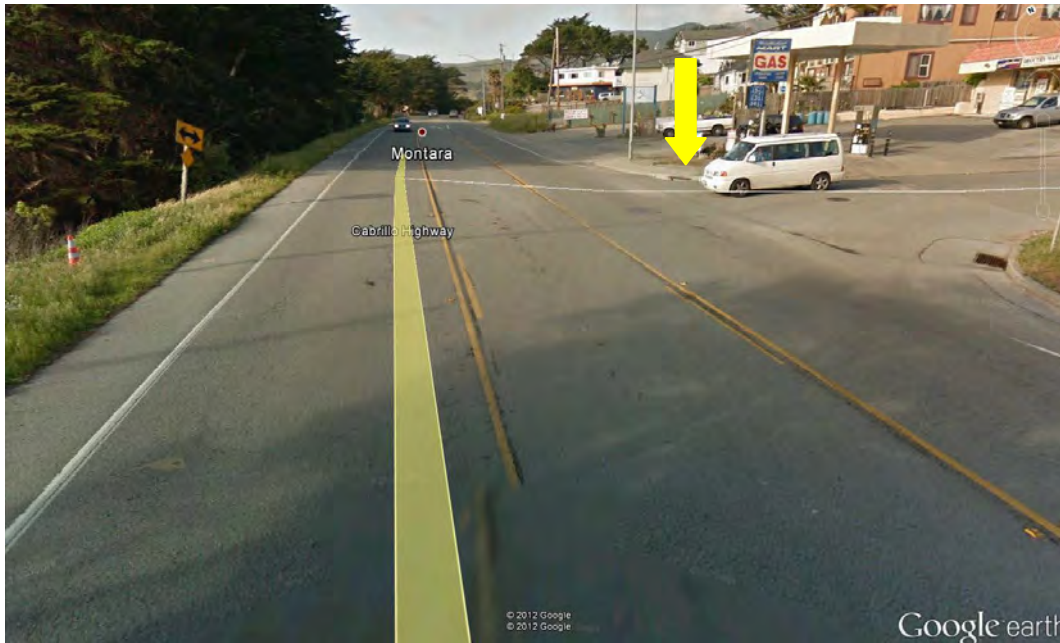
Photo 7: BMP-7 ~ Catch basin filter cartridges at 8th St and Cabrillo Highway

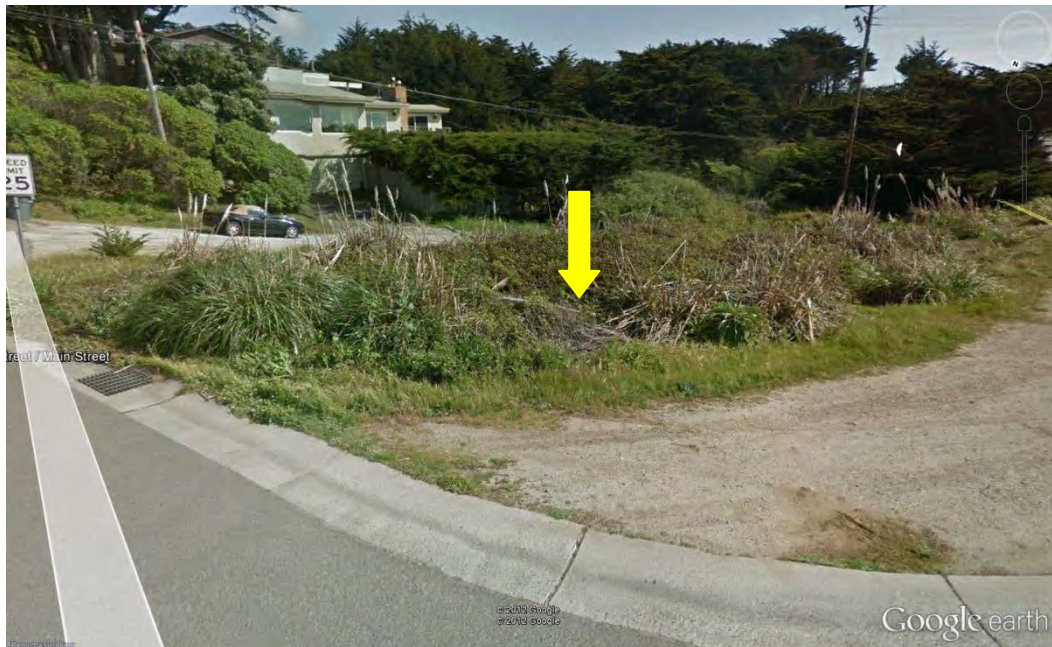
Photo 8: BMP-8 ~ Vegetated swale to be maintained and checked for capacity at 14th St and Farallone Avenue

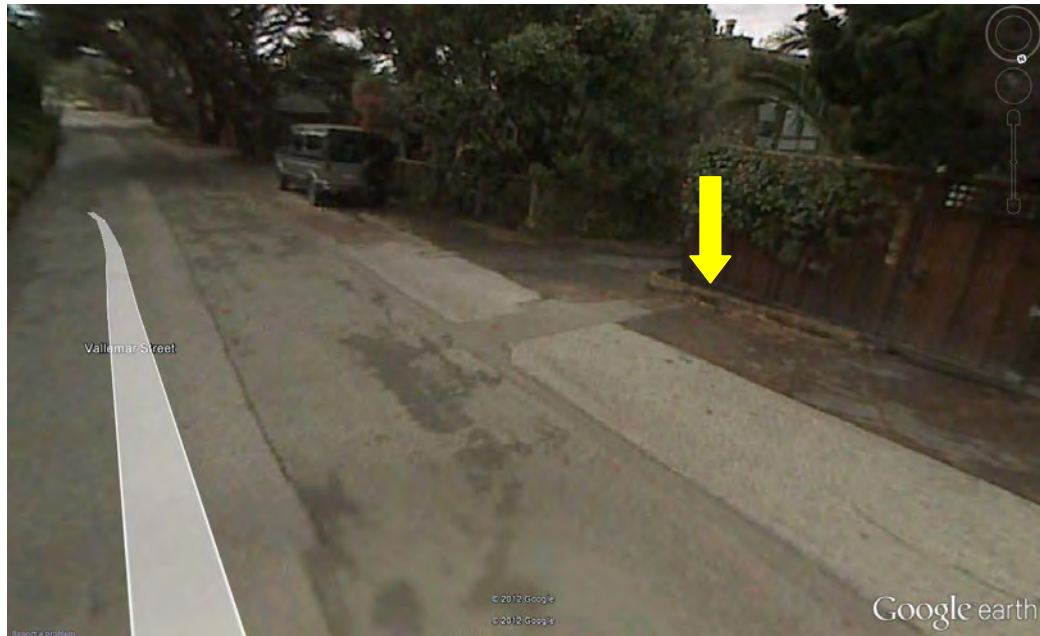
Photo 9: BMP-9 ~ Flume filter to be installed in Vallemar St prior to flow entering private property

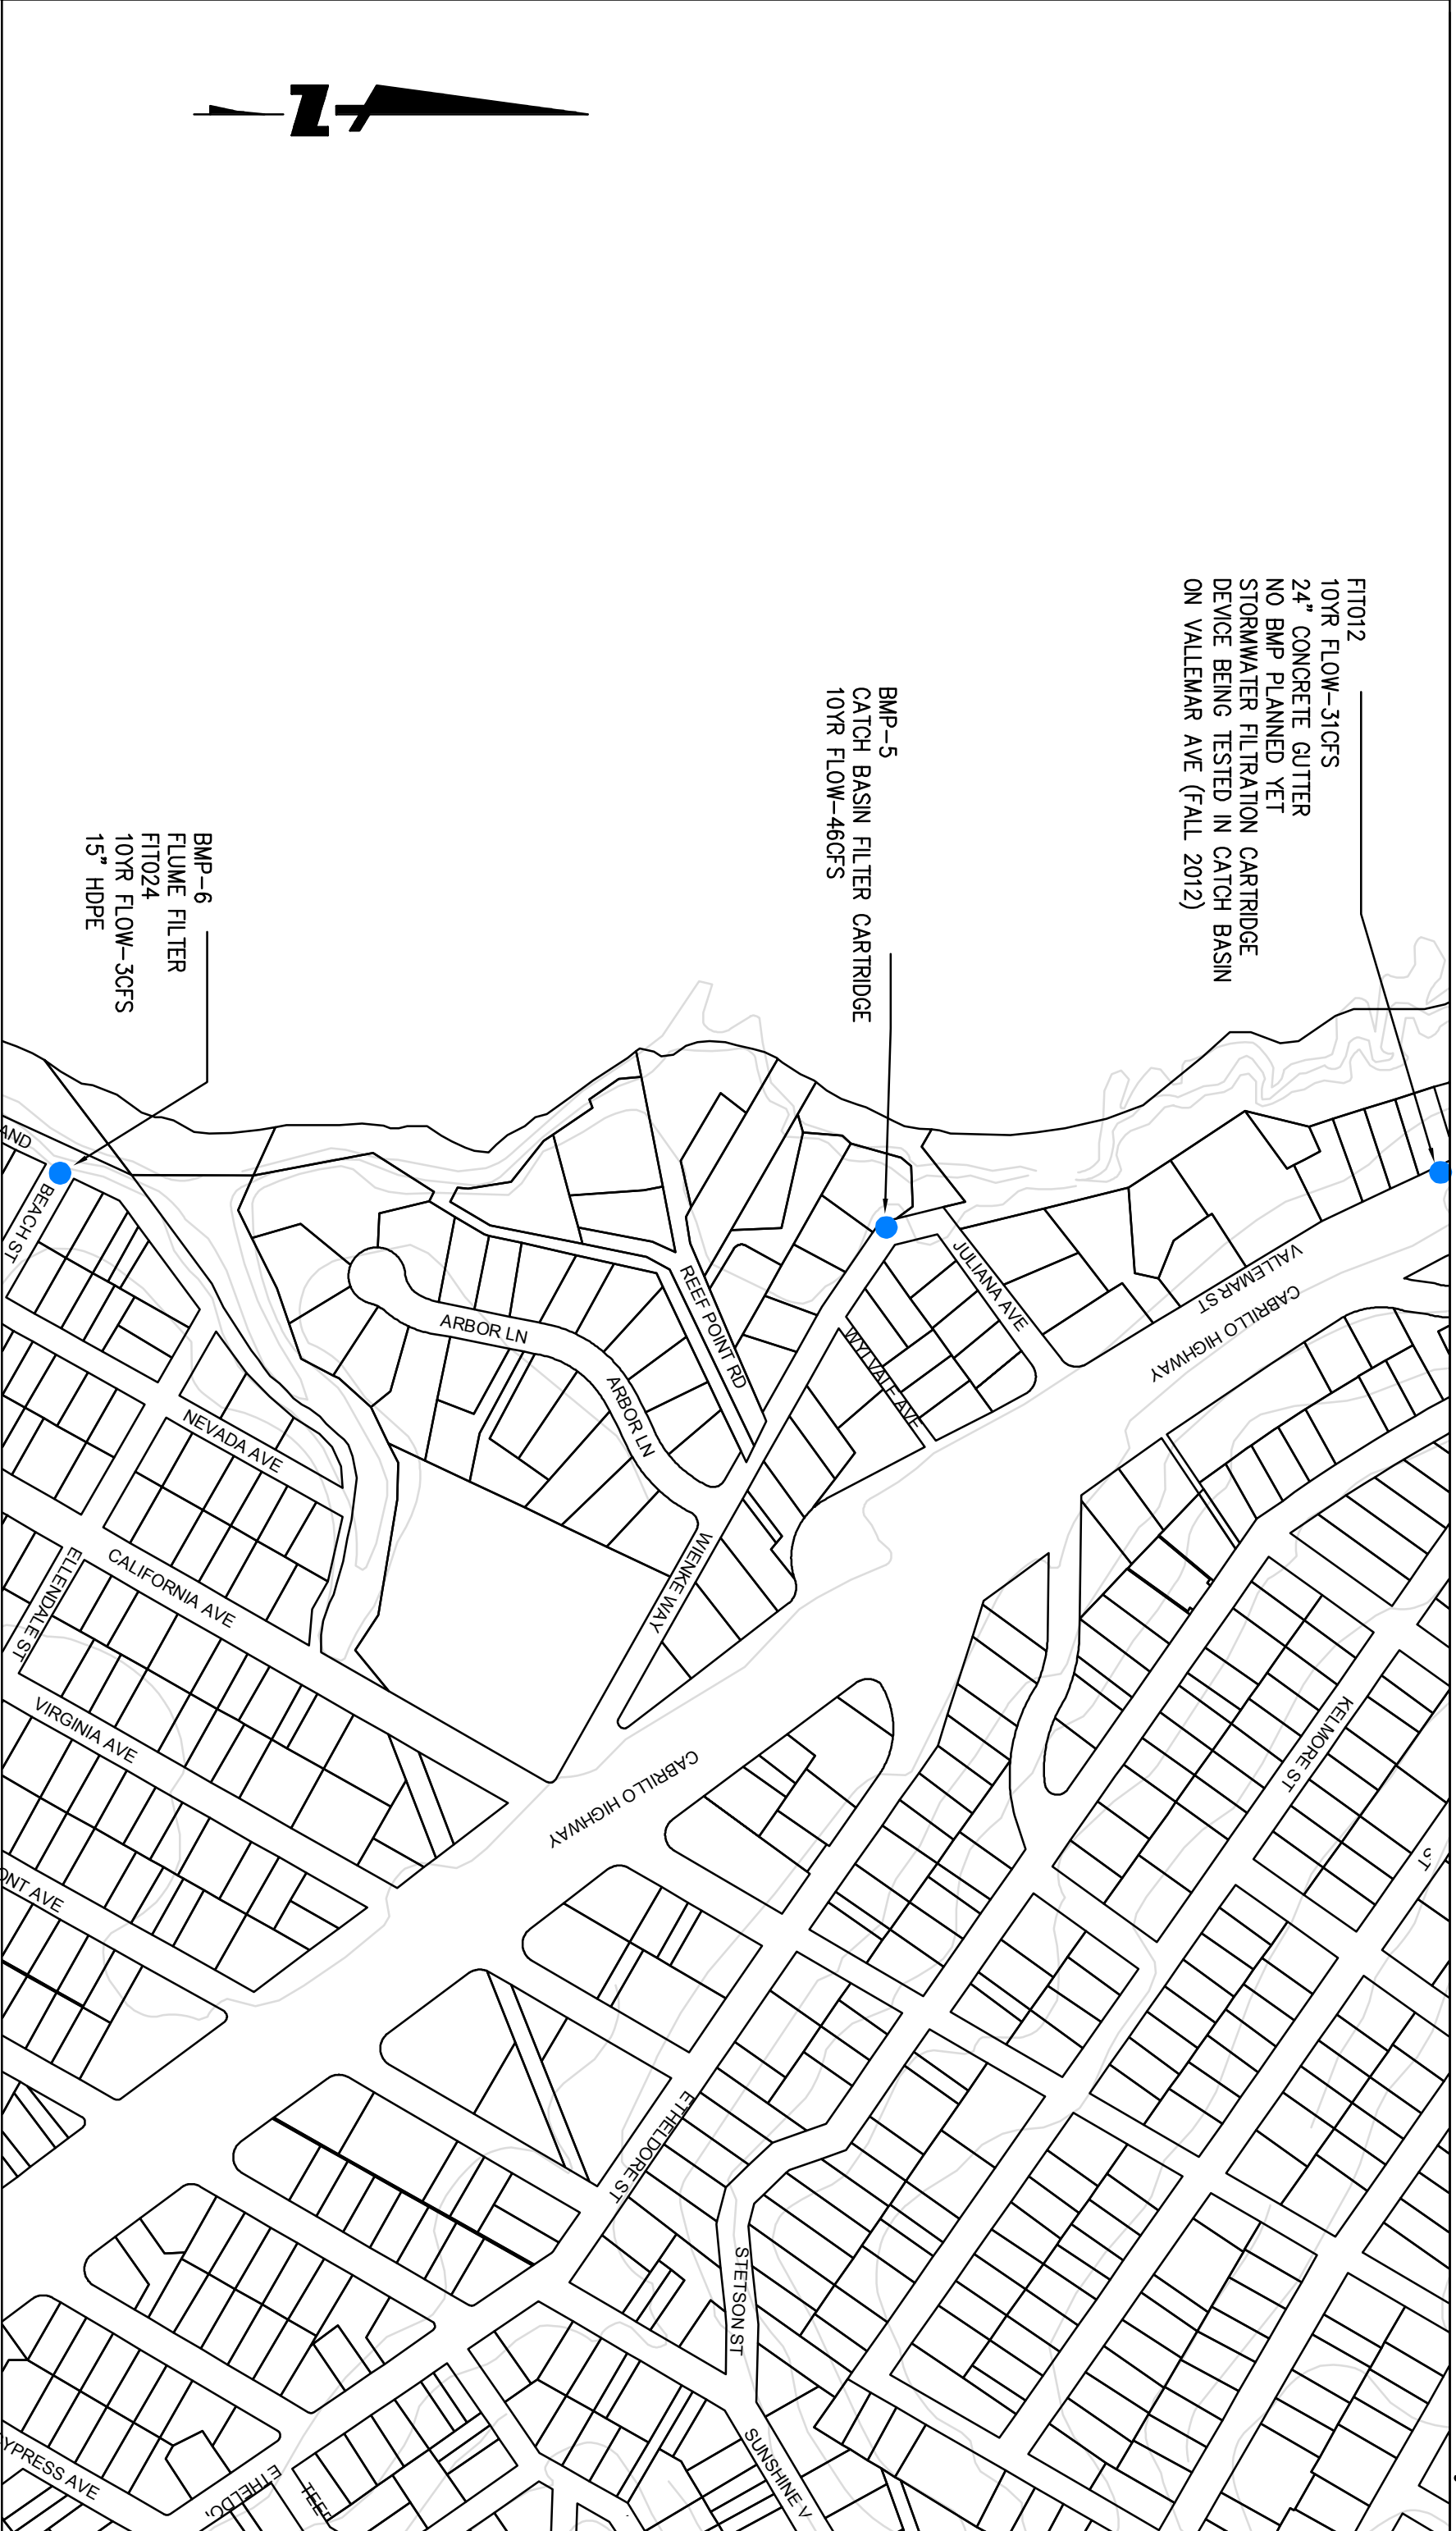
FIGURE 5C
 MIDCOAST STORM DRAIN INVENTORY AND ASSESSMENT
 PRIORITIZED OUTFALL BMP LOCATIONS
 DRAINAGE REPORT

FT1012
 10YR FLOW-31CFS
 24" CONCRETE GUTTER
 NO BMP PLANNED YET
 STORMWATER FILTRATION CARTRIDGE
 DEVICE BEING TESTED IN CATCH BASIN
 ON VALLEMAR AVE (FALL 2012)

BMP-5
 CATCH BASIN FILTER CARTRIDGE
 10YR FLOW-46CFS

BMP-6
 FLUME FILTER
 FT1024
 10YR FLOW-30CFS
 15" HDPE
