DRAINAGE REPORT

MIDCOAST STORM DRAIN INVENTORY AND ASSESSMENT PROJECT

THE COUNTY OF SAN MATEO

February 8, 2013

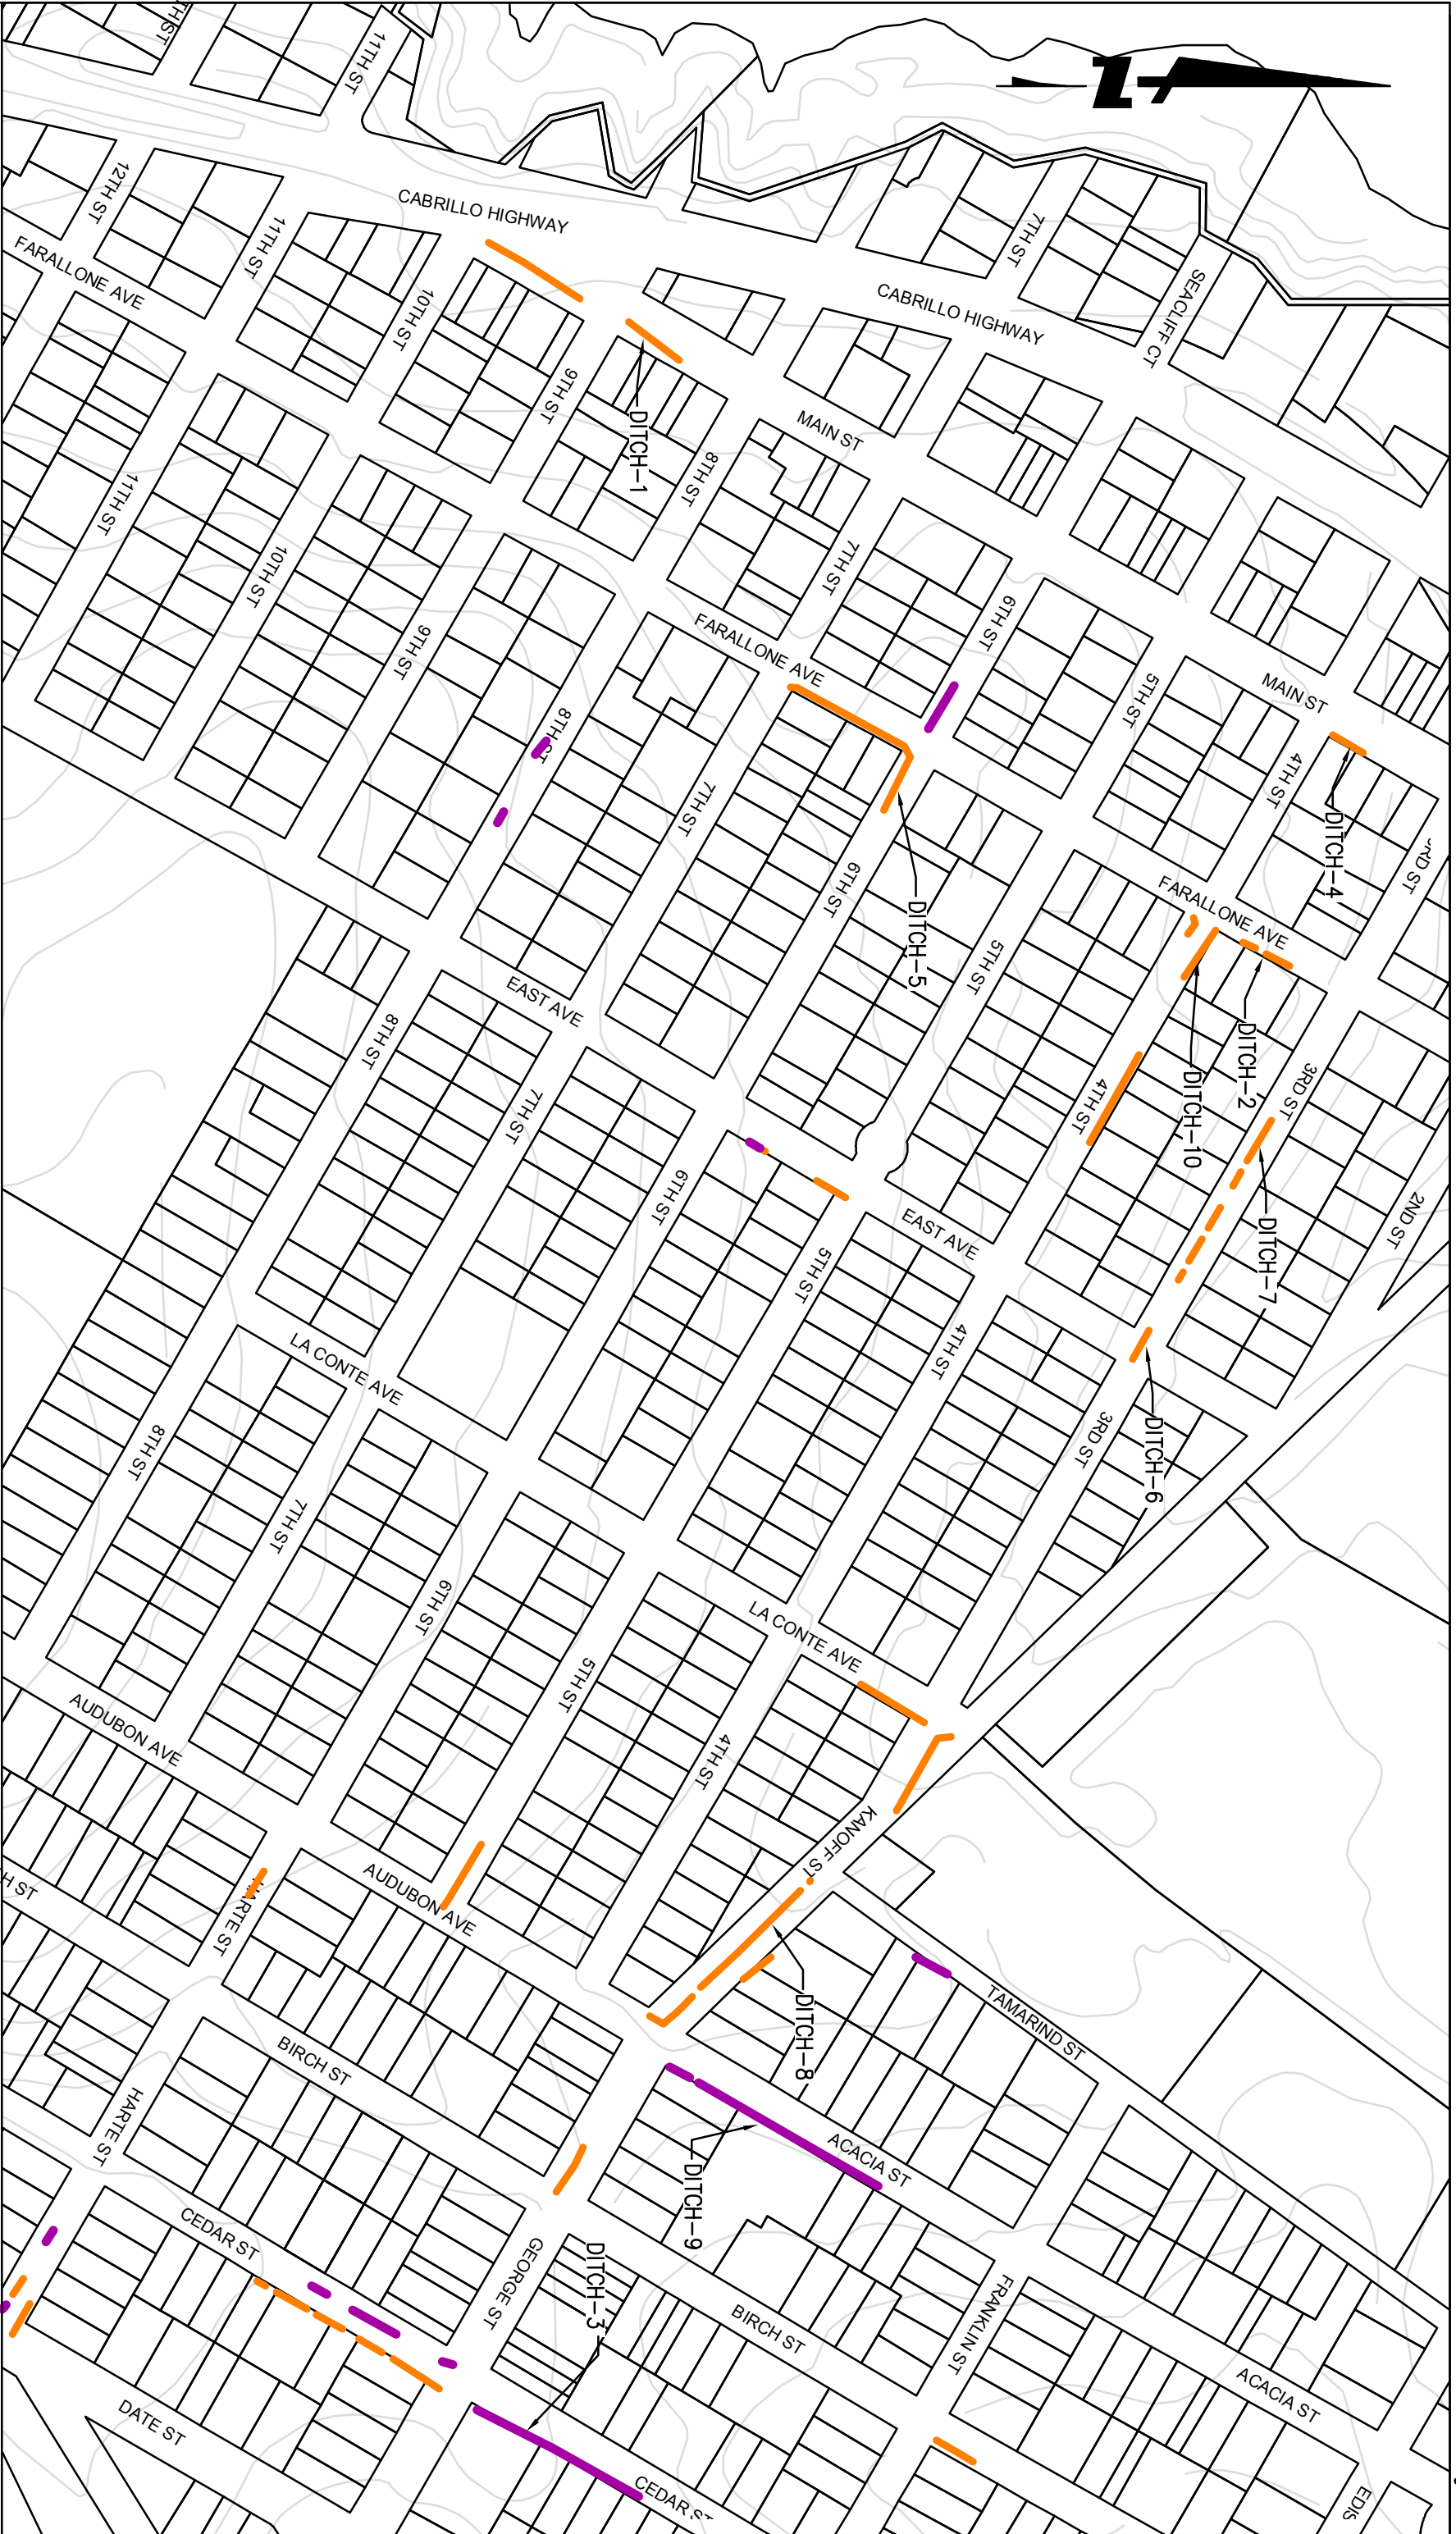
FIGURE 6
MIDCOAST STORM DRAIN INVENTORY AND ASSESSMENT
PRIORITIZED DITCHES FOR VEGETATION
DRAINAGE REPORT

The prioritization of the ditches was based on the 10-year flow, the ditch's proximity to its system outlet, the ditch's current condition/slope and the space available to establish a better defined ditch with greater volume and ability to replant with suitable vegetation. Check dams could be incorporated within ditches with slopes greater than 2% to reduce velocity and therefore improve sedimentation.

- DITCHES WITH SLOPE LESS THAN 2%
- DITCHES INUNDATED DURING THE 10-YEAR EVENT

The prioritization of the ditches was based on the 10-year peak flow rate, the ditch's proximity to its system outlet, the ditch's current condition/slope and the space available to establish a better defined ditch with greater volume and more suitable vegetation. Prioritized ditches are shown in Photos 10-19 and shown in Figure 6. A recommended ditch best management practice would consist of replacement of existing ditch soils with a biotreatment soil mix consisting of a soil and compost mix consistent with requirements in the San Francisco Bay Region Municipal Regional Stormwater Permit with plantings suited for trash capture. Some ditch widening or deepening may be required depending on density and type of vegetation selected. Erosion control fabric is recommended where slopes are greater than one percent.

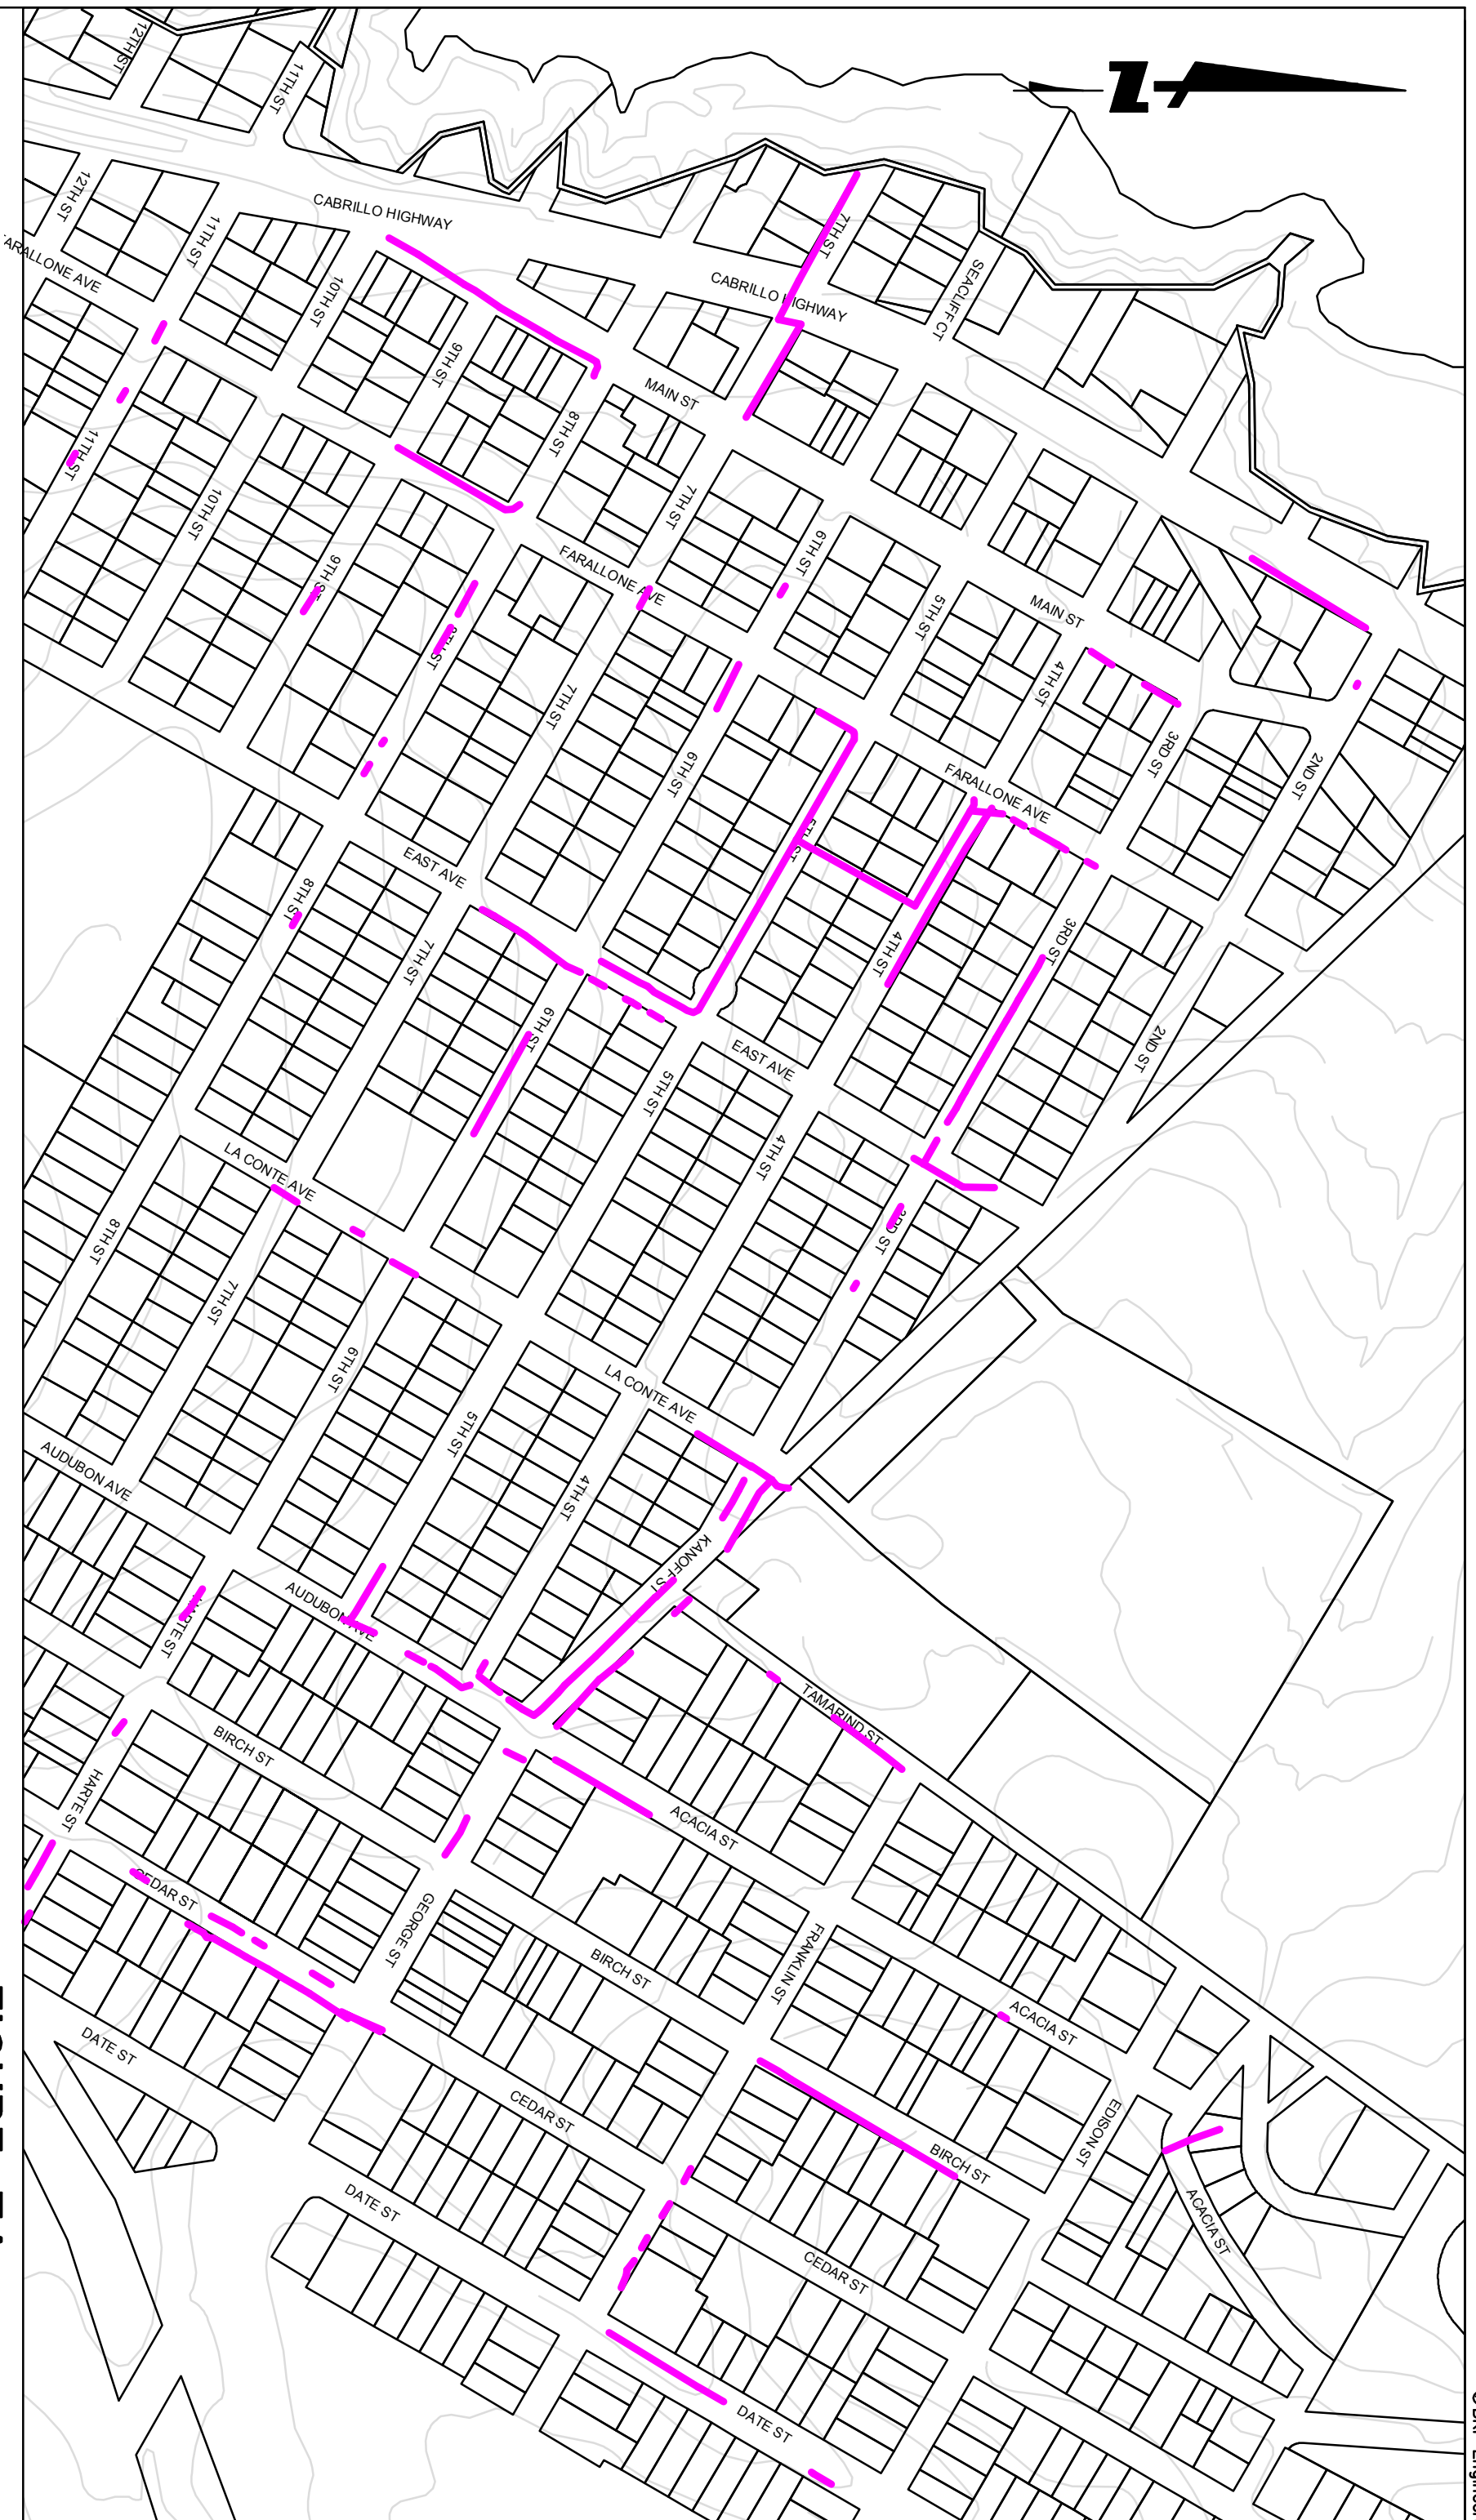
FIGURE 7A
MIDCOAST STORM DRAIN INVENTORY AND ASSESSMENT
PIPES INUNDATED DURING 10-YEAR EVENT
DRAINAGE REPORT

The hydrologic data processing identified locations within the MidCoast storm drain system that are undersized. The hydraulic analyses yielded areas of inundation during the treatment, 2-, 10-, and 100-year storm events. Inundated pipes and ditches during a 10-year storm event are shown in Figures 7A-7G, and summarized in Appendix C.

Specific recommendations for addressing deficiencies are not included as a part of this Report. In general, drainage corrections would consist of adding a storm drain line parallel to existing ditches, retrofitting ditches to increase capacity, or upsizing existing storm drain pipes. Deficiencies associated with inadequate inlet capacity were not addressed as part of this study.
